Terragong Staircase

By Simon Milner.

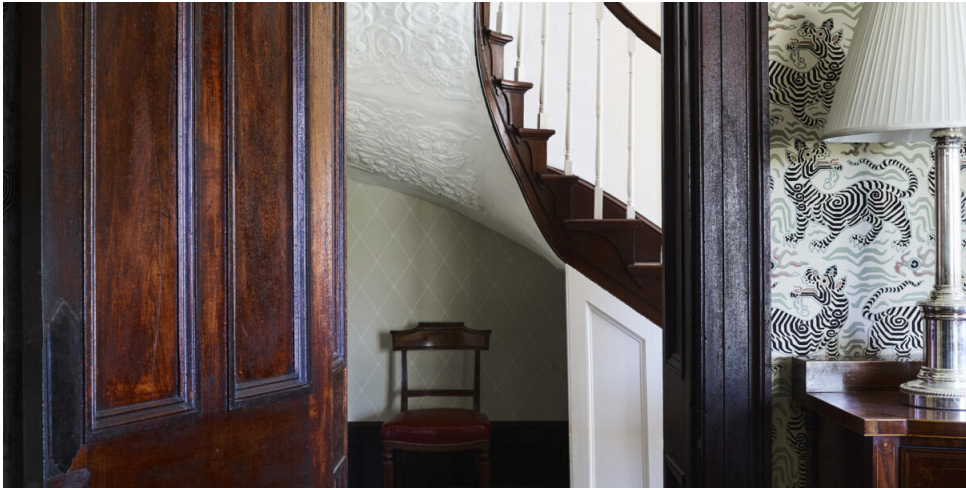
Terragong Staircase

At some point in the past the bannister, stair treads and risers - as well as the skirting board that winds its way up the stairs and along the first floor landing - had been given a coating of an Estapol-like high gloss varnish. Not only was the high-gloss finish at odds with the original cedar surfaces in the house such as the windows, window casements, doors and door frames, the colour had turned an odd shade of deep orange/marmalade through oxidisation.

We all underestimated the time it would take to complete the job! Rudi's original four-day estimate quickly turned into eight days, with the first six days alone spent stripping the estapol finish from the wood, using a variety of strippers (some organic, some highly caustic, not all effective), eventually resorting to a heat gun which was the only thing able to shift the mirror-like coating.

Once the wood was bare, Rudi's artistry was put into play, creating a custom blend colour varnish to match the other cedar wood in the house, painstakingly applying layer after layer to achieve the right depth of colour.

Once stained, the wood (bannister, risers, treads and skirting board) was then French polished using traditional shellac and methylated spirits and buffed to a glorious satin finish which glows. Rudi also gave the front door and large passage door under the stairs the same treatment, revealing their original beauty.

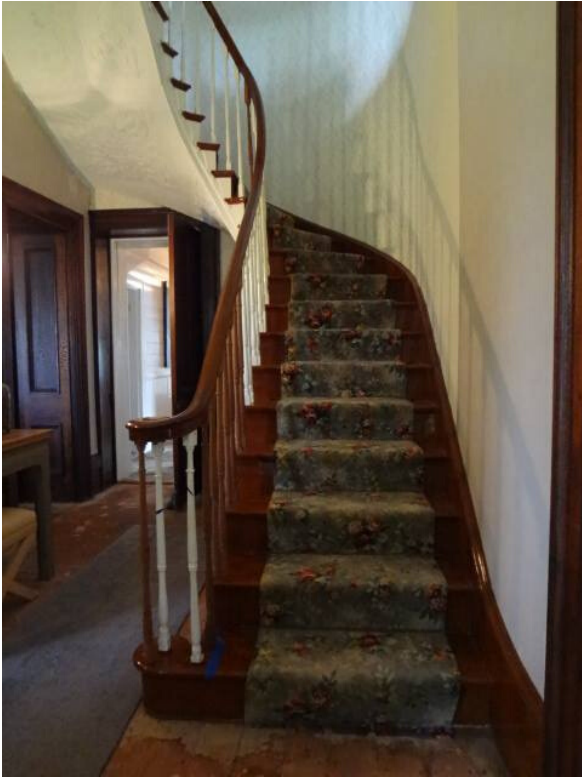
The staircase mid-refurbishment, with the original stair runner and discoloured high-gloss finish. The unpainted balusters are the newly turned ones in cedar.

One of the first repair jobs we undertook as part of our renovation and restoration of Terragong was to the staircase, with our specialist woodworker Richard putting right some of the earlier repairs; this included replacing broken and mismatched balusters with new ones which we commissioned from a Sydney-based wood turner, who used one of the originals as the model for the new replacements - a dozen in total. These were crafted using cedar wood to match. We took the opportunity to commission a newel post at the same time, as the original had been removed at some stage (probably during the repairs made immediately following the earthquake in the early '60s); the design of this too was based on the shape of the original balusters.

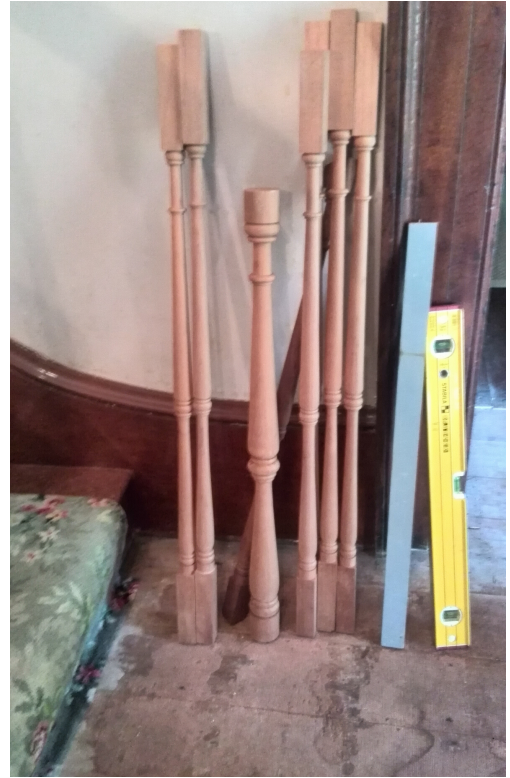
The newly turned balusters and newel post, awaiting installation

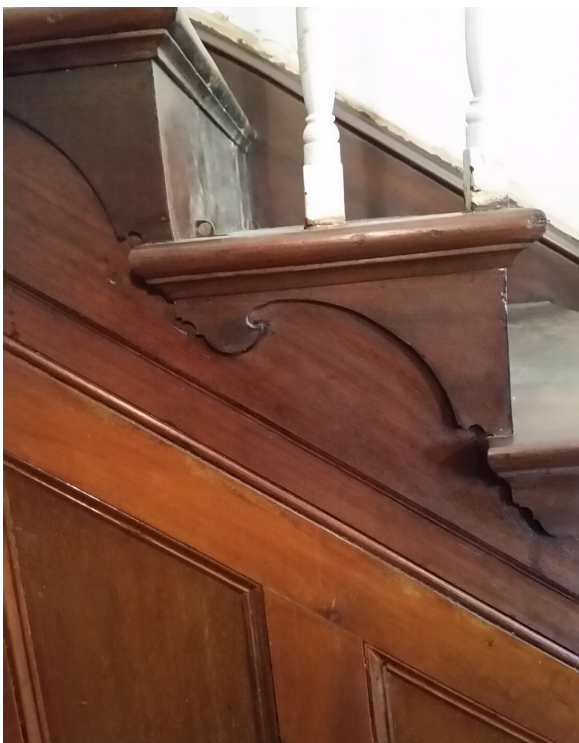
The new stain on the treads, contrasting with the orange hue of the Estapol coat on the side panel.

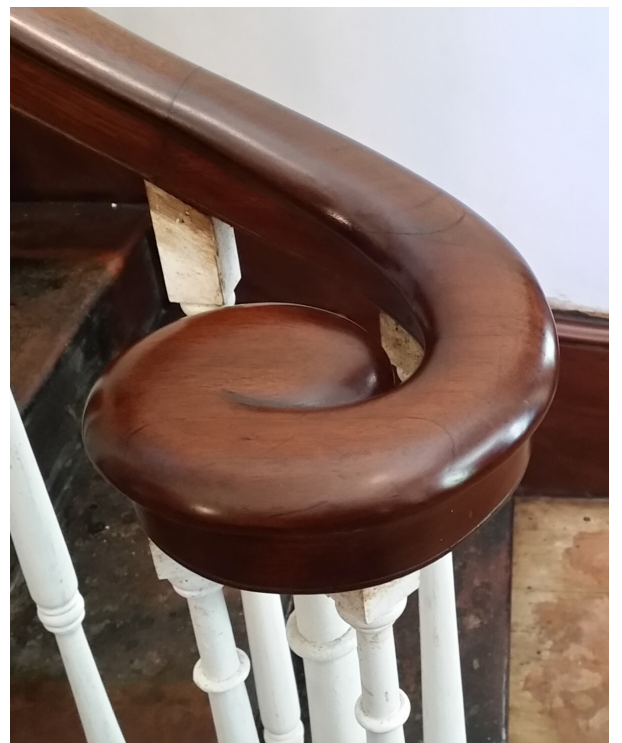
The completed bannister with its new stain and French polish.
